**Initial Site Investigation &
Emergency Corrective Action Report**

**Grace United Methodist Church
36 Central Street
St. Johnsbury, Vermont 05819**

SMS Site #: 2006-3478

R.E.A. Project No. 26-012
R.E.A. Document #: 26012ISI

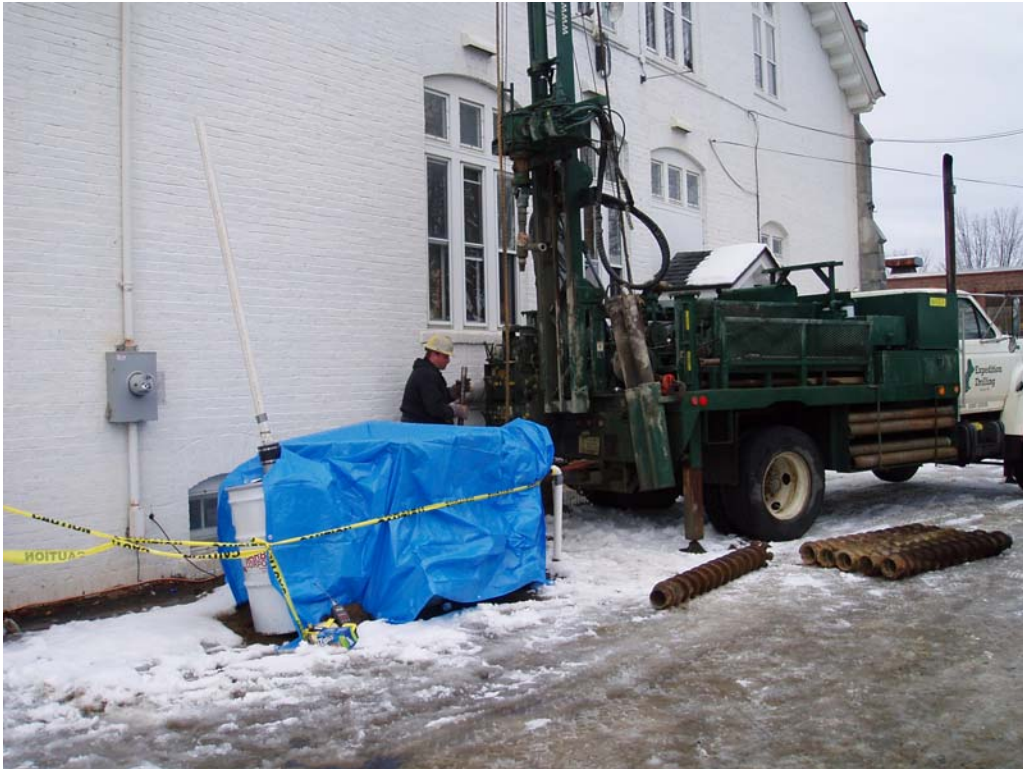
GRACE METHODIST CHURCH – ST. JOHNSBURY, VERMONT
(Installation of MW-1 – View Toward East)

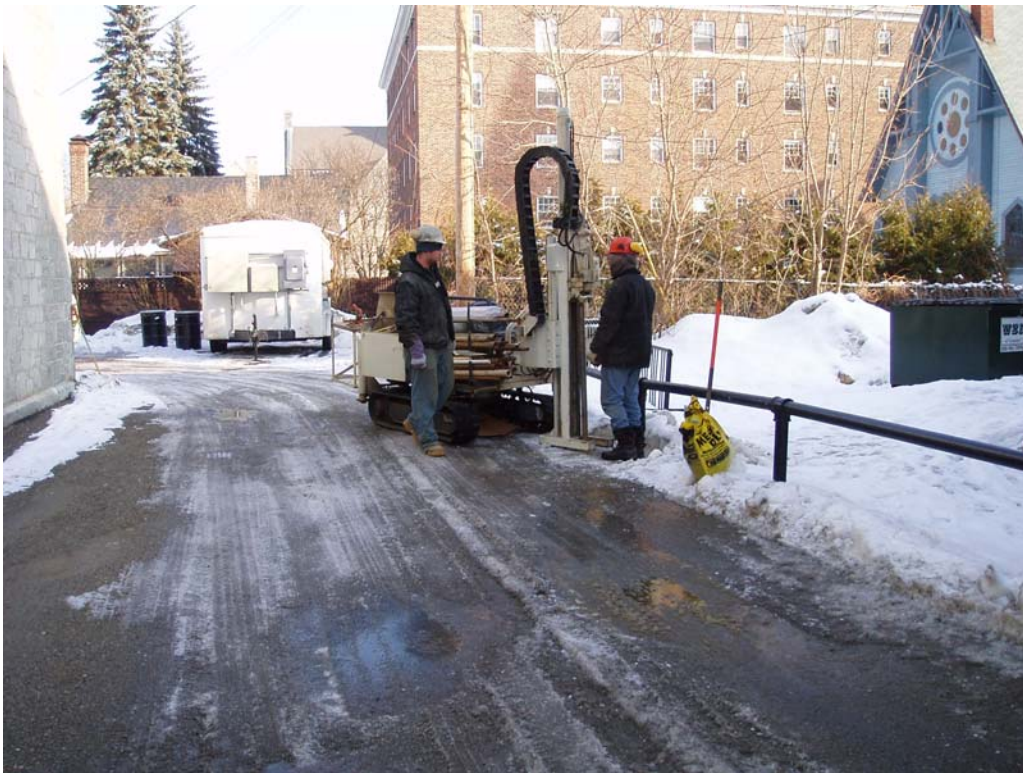
GRACE METHODIST CHURCH – ST. JOHNSBURY, VERMONT
(Installation of MW-2 – View Toward Northeast)

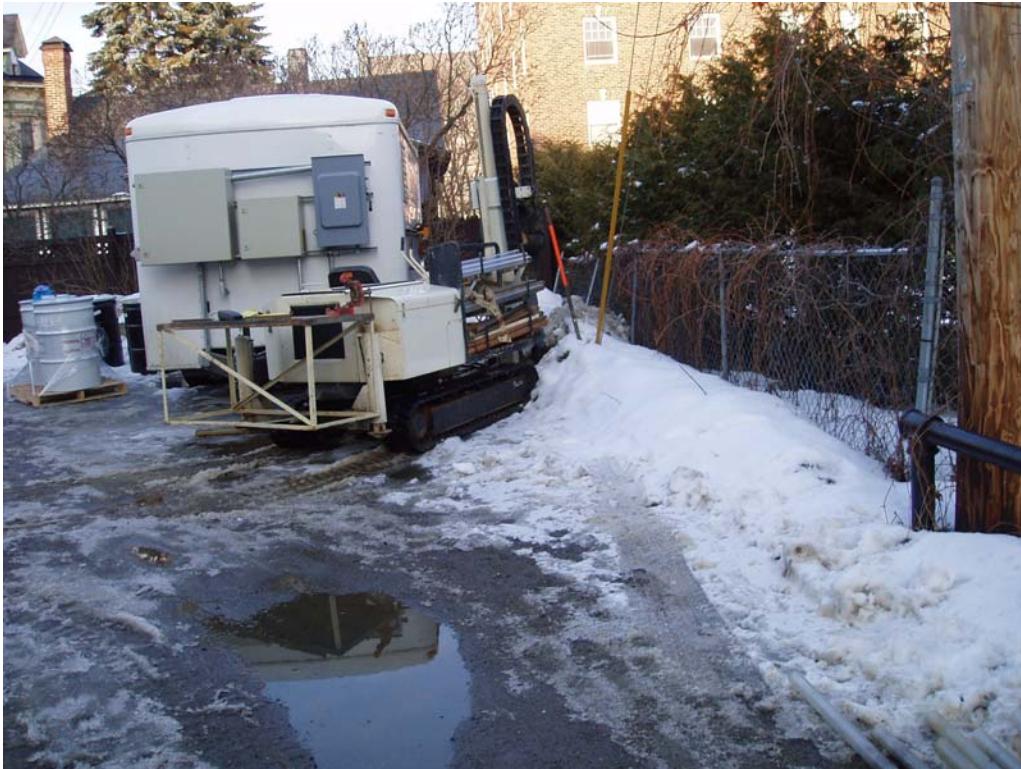
GRACE METHODIST CHURCH – ST. JOHNSBURY, VERMONT
(Installation of MW-3 – View Toward Northeast)

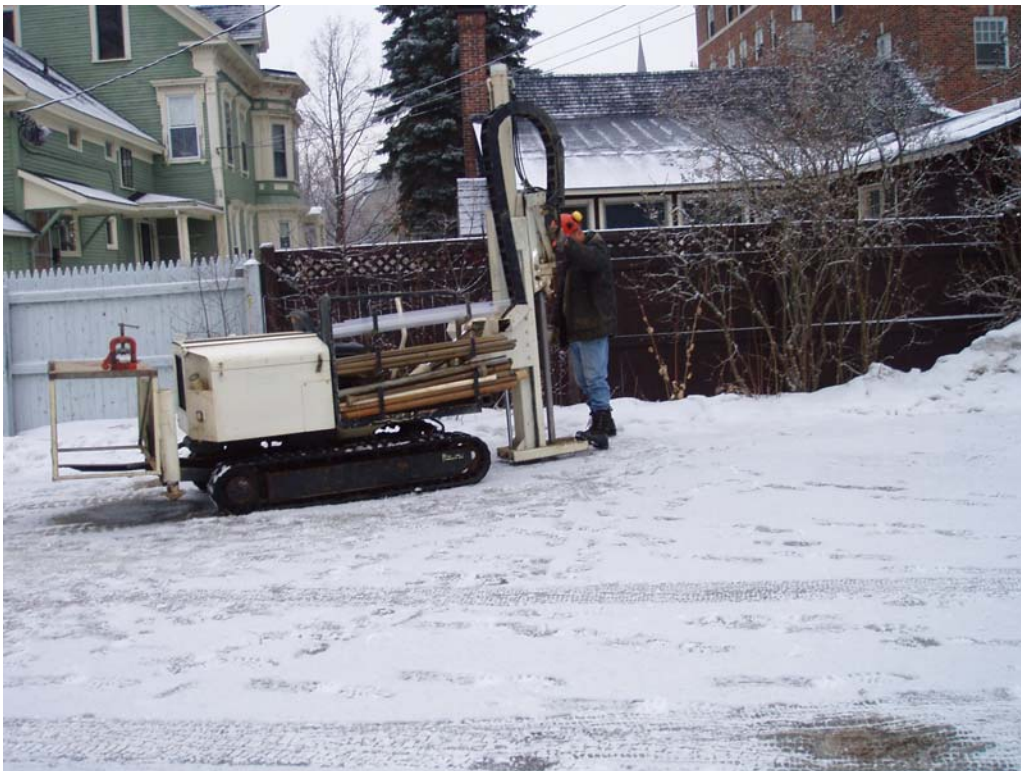
GRACE METHODIST CHURCH – ST. JOHNSBURY, VERMONT
(Installation of MW-4 – View Toward North)

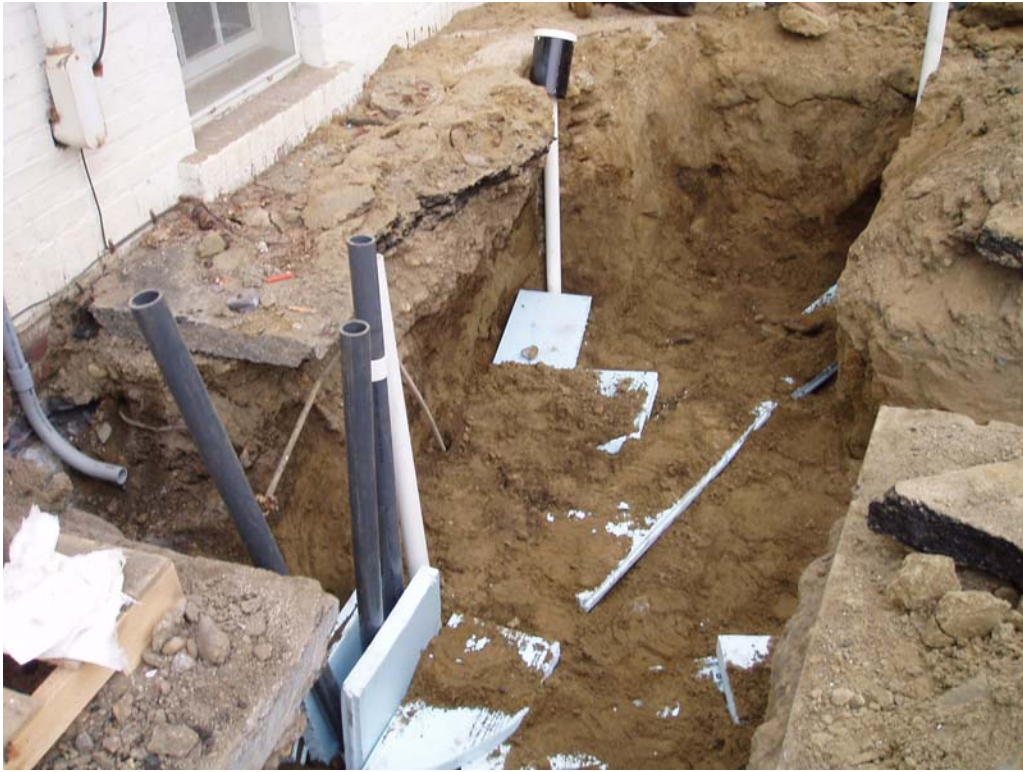
GRACE METHODIST CHURCH – ST. JOHNSBURY, VERMONT
(Trenchwork and Subsurface SVE Piping)

Trenching and subsurface piping was implemented between 9 and 10 February 2006. The SVE wells were connected by individual pipes installed within subsurface trenches to a manifold located within an equipment enclosure. Subsurface conveyance piping for the SVE system was constructed of two-inch diameter, schedule 80 PVC. Subsurface piping was placed approximately three to four feet bgs, and bedded with appropriate fill material. Insulation board was installed on top of the bedding material to reduce frost penetration. Suitable materials were used to backfill on top of the insulation board to the pre-existing grade, which was compacted in at least 12-inch lifts. Due to freezing conditions, the trenching and former UST area were not repaved; however, this task should be completed as soon as weather permits.

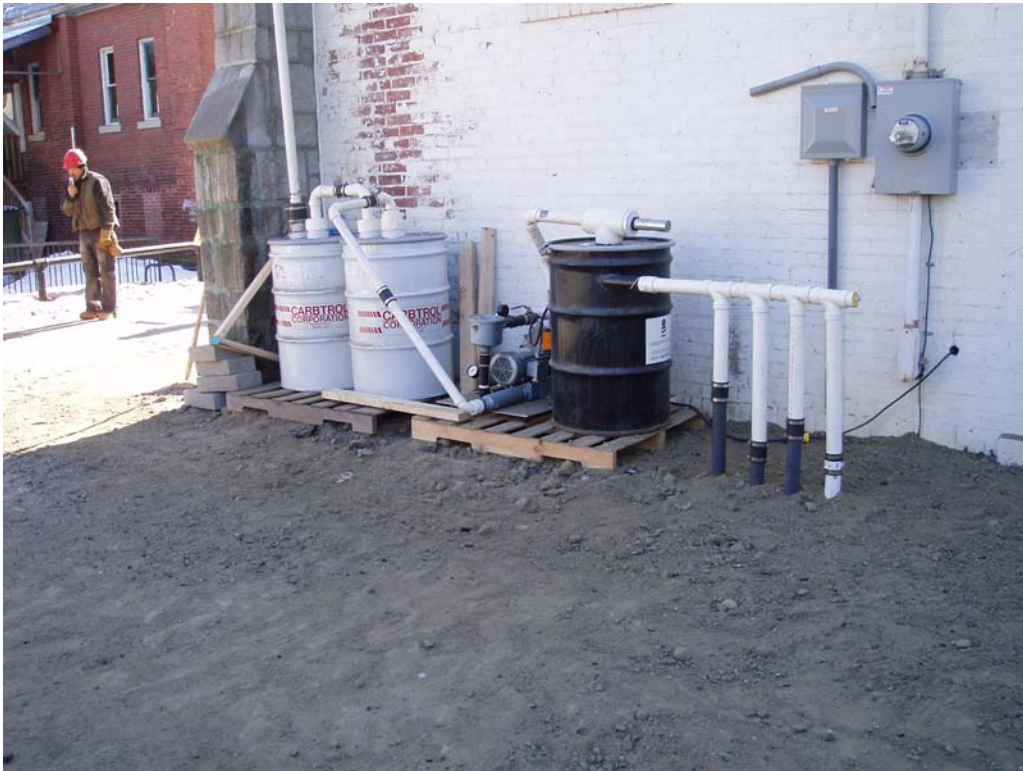
GRACE METHODIST CHURCH – ST. JOHNSBURY, VERMONT
(Above-ground SVE System Components – View Toward Southeast)

The SVE system is comprised of four subsurface vapor extraction points, which connect into a manifold that empties into a vapor-liquid separating drum. The drum is connected to a 1.5 horsepower regenerative blower, and two in-line 200-pound vapor phase GAC drums for vapor treatment. The system is housed in an 8 by 3 foot shed.

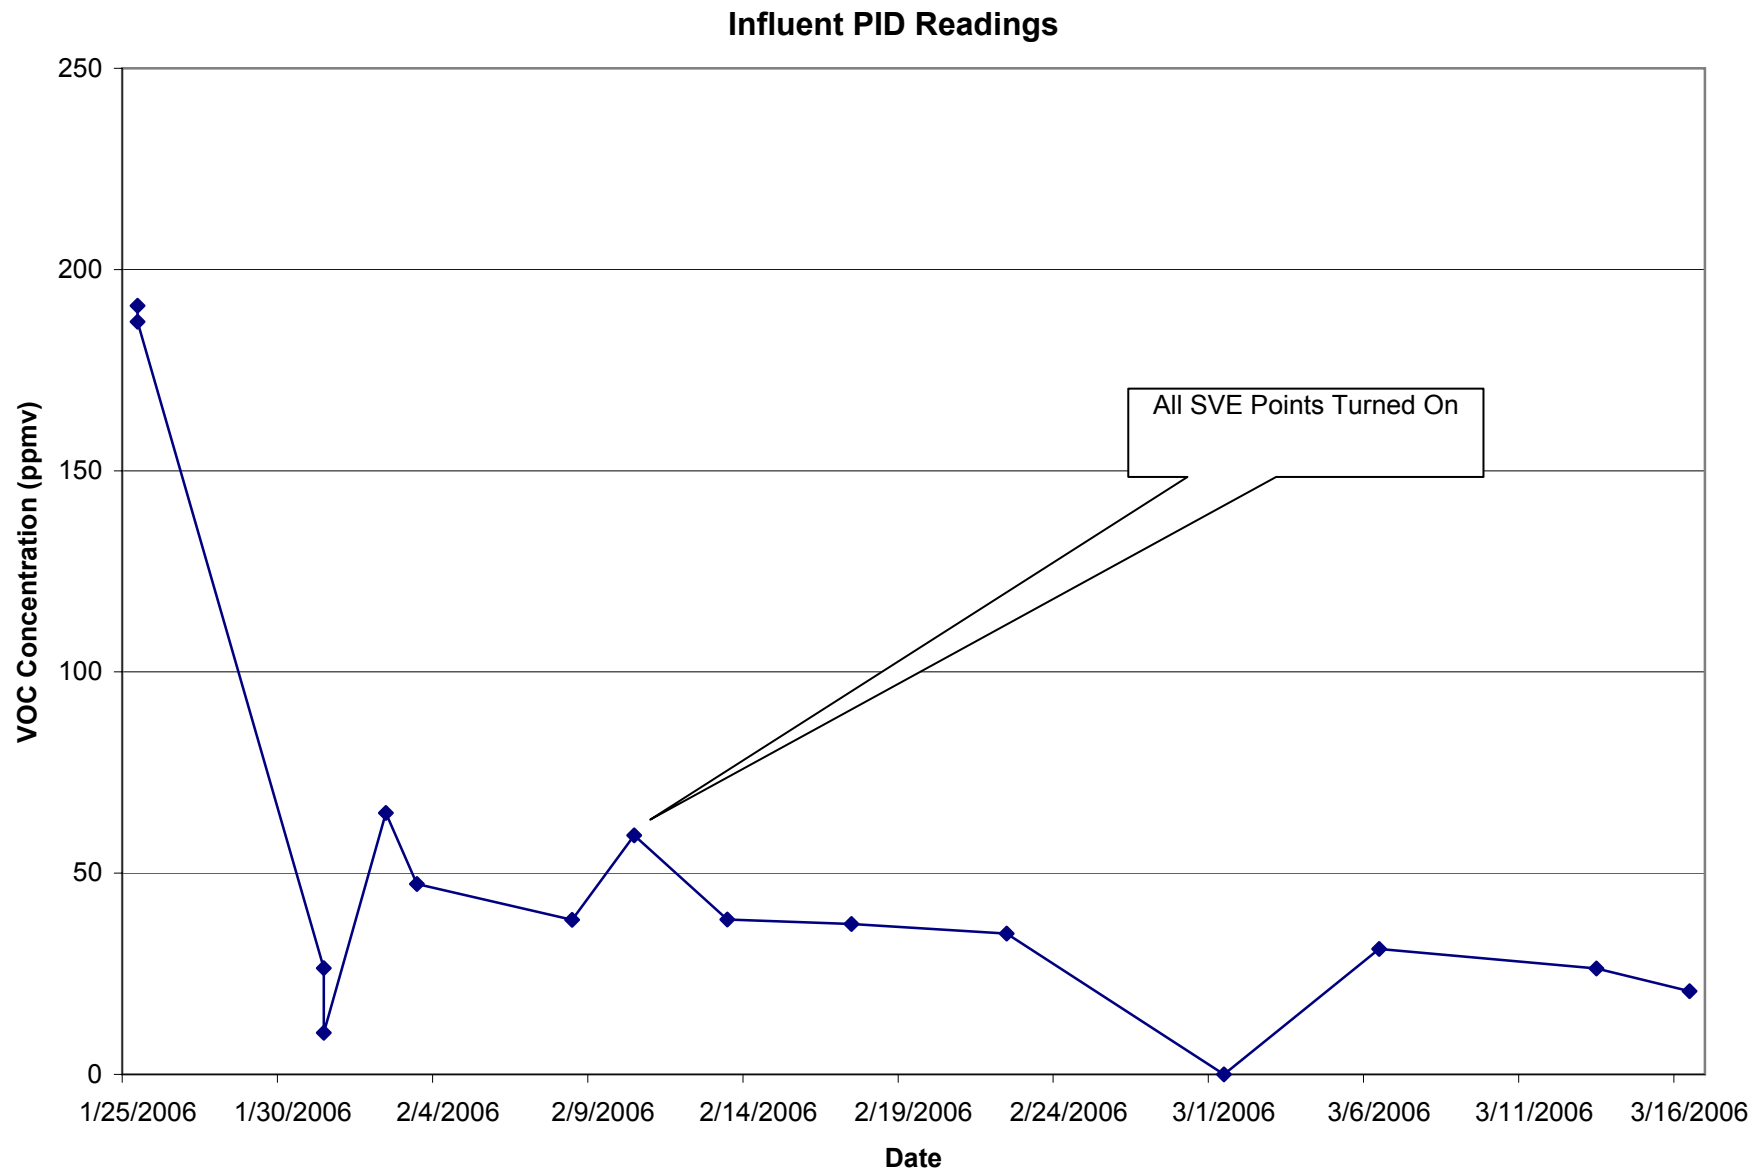
Figure 5
SVE Influent PID Readings
Grace United Methodist Church
St. Johnsbury, Vermont

- C-1 = Carbon Unit #1
- C-2 = Carbon Unit #2
- ppmv = parts per million volume
- PID = Photionization Detector
- VOC = Volatile Organic Compound
- VOC concentrations measured with a Photoionization Detector, calibrated to a benzene reference.

The petroleum vapors recovered through the soil vapor extraction system are treated through two in-line granular activated carbon (GAC) drums. Influent and effluent photoionization detector (PID) readings are collected on a regular basis to determine the volatile organic compound (VOC) destruction efficiency. Influent readings between 25 January and 6 March 2006 have ranged from 10.3 to 190 ppmv. A table summarizing VOC treatment efficiency and a chart summarizing influent PID readings are included in Appendix E.

- A soil vapor extraction (SVE) system was installed in and downgradient of the source area at the request of the VT DEC to prevent further downward migration of the fuel oil toward the groundwater and to alleviate possible threats to indoor air of the church basement. Influent PID readings have ranged between 0.0 and 191 ppmv.
